# Manhole Inspection Summary

Manhole # S17M\_\_003MH

Insp Date: **4/10/08 1:15 PM**

**Location** Address: **2401 frederick-ashton shopping center** Cross Street: **s catherine st**

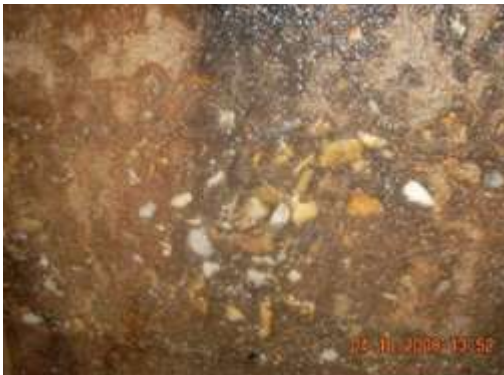
Defect 2

Condition: ☐ Sound ☐ Cracked ☐ Root Intrusion ☐ Loose Brick ☒ **Deteriorated**

Infiltration: ☐ None ☐ Joint ☐ Cracks ☐ Mortar ☐ Roots ☒ **Wall**

deteriorated barrel wall, infiltration @ barrel wall

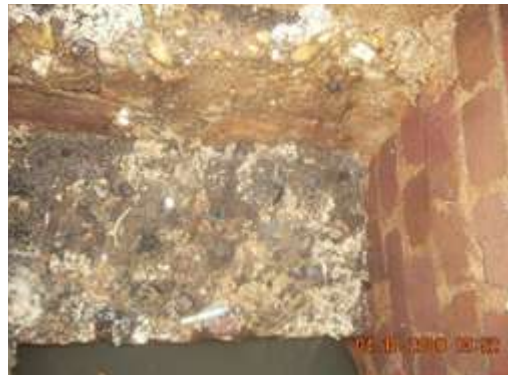
Defect 1

Condition: ☐ Sound ☐ Cracked ☐ Root Intrusion ☐ Deteriorated ☐ Leaks ☒ **Debris**

grease on bench

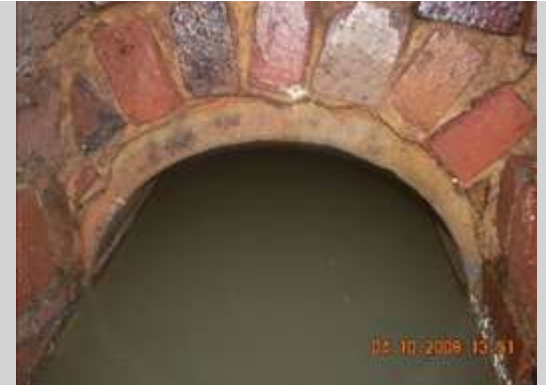
12 O'Clock Outflow

Pipe Height: **18** (in.) Rod and Bar (Angled)  
Pipe Material: **Clay** ☐ Pipe Lined  
Invert Depth: **23.55** (ft.) Flow Characteristics: **Slow**  
Deposits: ☒ None ☐ Mud ☐ Sludge ☐ Debris ☐ Grease  
Silt Depth: **0** (in.) Deposits Extent:  
Infiltration: **None** Pipe Seal Cond: **Sound**

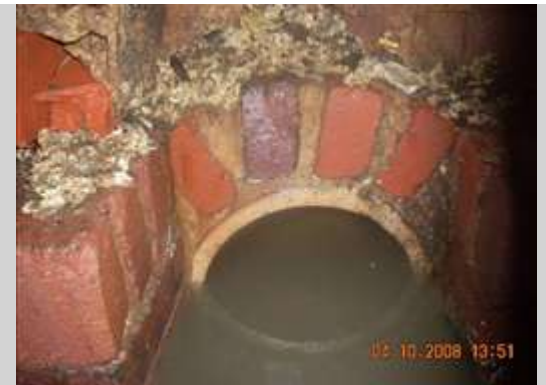
3 O'Clock Inflow

Pipe Height: **7.2** (in.) Rod and Bar (Angled)  
Pipe Material: **Clay** ☐ Pipe Lined  
Invert Depth: **23.12** (ft.) Flow Characteristics: **Slow**  
Deposits: ☒ None ☐ Mud ☐ Sludge ☐ Debris ☐ Grease  
Silt Depth: **0** (in.) Deposits Extent:  
Infiltration: **None** Pipe Seal Cond: **Sound**

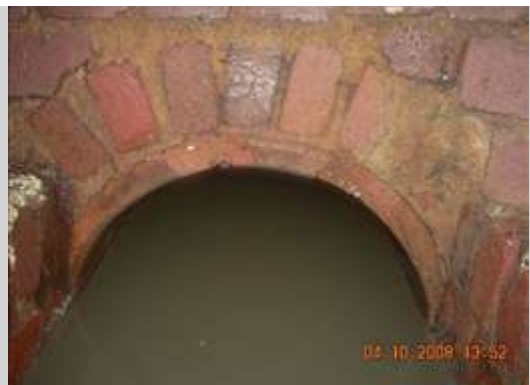
6 O'Clock Inflow

Pipe Height: **19.2** (in.) Rod and Bar (Angled)

Infiltration: **None** Pipe Seal Cond: **Sound**
